Monitoring Data RecordProject Title: R-2417BB (Site 6) COE Action ID: 200201326Stream Name: \_\_\_\_\_ DWQ Numbers: 3378City, County and other Location Information: Lee County, Sanford Bypass (Sta. 540+20 to 555+00 -L- RT.)Date Construction Completed: Water was turned into the stream in Oct. 2006. Streambank reforestation was completed in Jan. 2007.Monitoring Quarter: ( 2 ) of 8Ecoregion: \_\_\_\_\_ 8 digit HUC unit: 03030004

2nd Quarter – August 2007

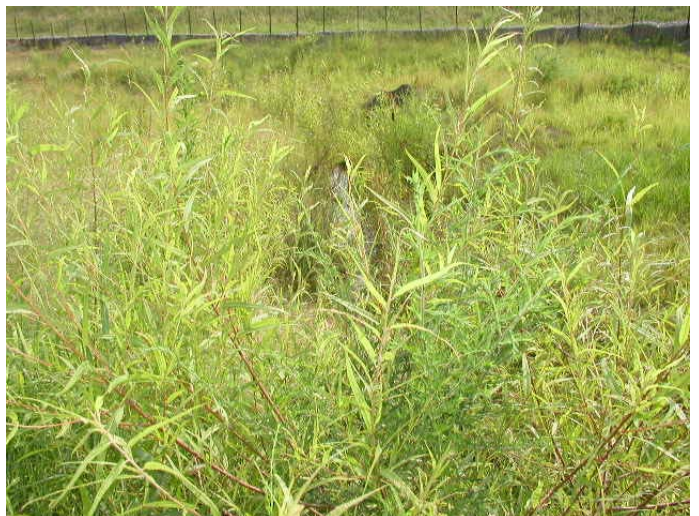
Photo Point #6 (Downstream)

8/7/07	PP #6 Upstream Sta. 546 +75	PP #7 Downstream Sta. 545+60	Station Number	Station Number	Station Number
Structure Type	Crossvane	Crossvane			
Is water piping through or around structure?	Water is piping through the crossvane	Water is piping through the crossvane			
Head cut or down cut present?	Slight headcut				
Bank or scour erosion present?					
Other problems noted?
